Tree Preservation Assessment

**State Route 82
El Camino Real Roadway Renewal Project
San Mateo County, CA**

**PREPARED BY:
HortScience | Bartlett Consulting
325 Ray St.
Pleasanton, CA 94566**

November 2021

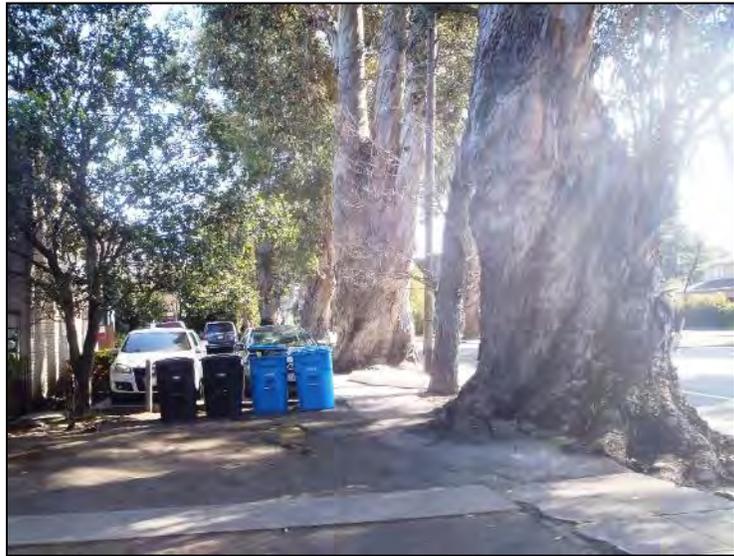
Photo 1: Looking south at blue gum #69, shows the typical growing conditions and available growing space around trees on the east side of El Camino Real.

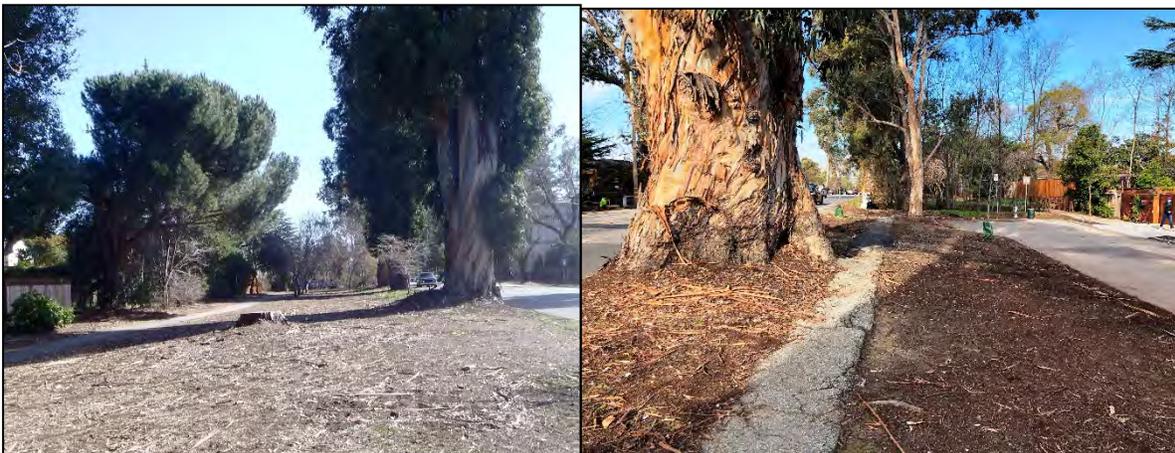
Photo 2 (L): Looking south at blue gum #15. A substantial undeveloped area existed east of trees #2-20, however several of the trees in this area were still growing at the edge of ECR.

Photo 3 (R): Looking north at blue gum #23, with ECR on the left and Highway Rd. on the right. Although not as extensive, there was some undeveloped land between the trees and Highway Rd.

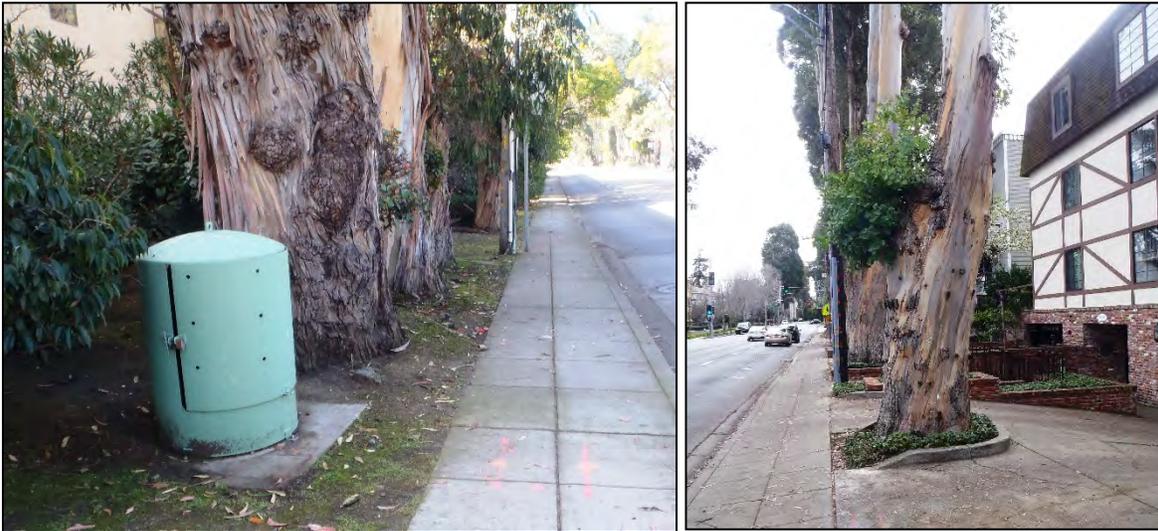
Photo 4 (above L): Looking north at blue gum #353-355, which were growing behind the sidewalk and in what is essentially the landscape of the adjacent apartment complex. This was typical of the growing conditions on the west side of ECR.

Photo 5 (above R): Looking south at blue gum #333. It had been preserved in a very small cut-out in the concrete between two driveways.

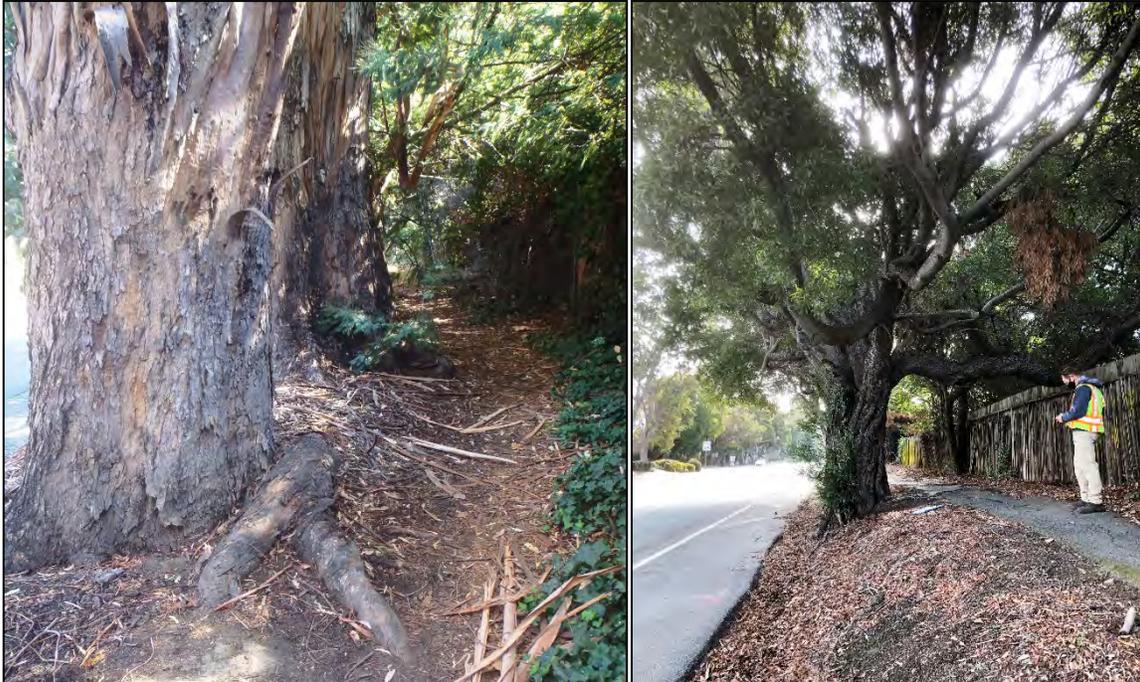
Photo 6 (above L): Looking south at the base of blue gum #319, showing the growing condition adjacent to trees #303-321. Neither sidewalk nor curb and gutter were present in this area.

Photo 7 (above R): Looking south at blackwood acacia #979. The tree was growing on a slope on the west side of ECR, with the sidewalk to the west (L) at a higher grade than ECR to the east (R).

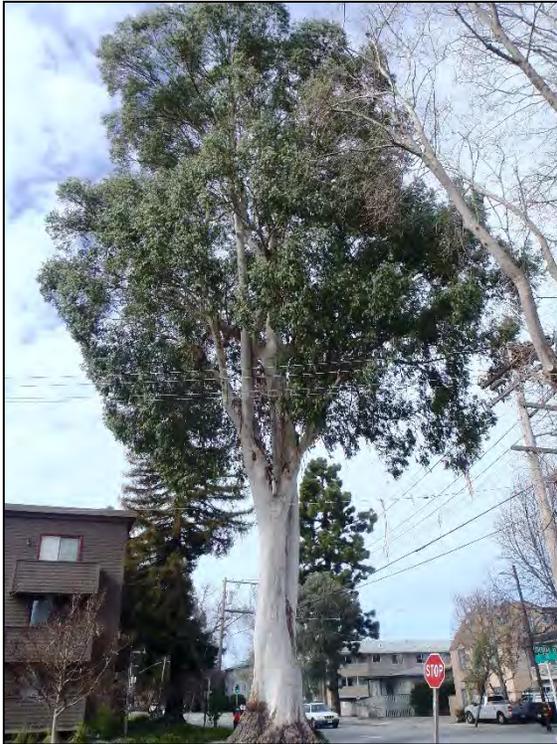
Photo 9 (L): Looking north at manna gum #437. Although the tree had been topped and reduced, it was in good condition, with better form and structure than those in fair condition.

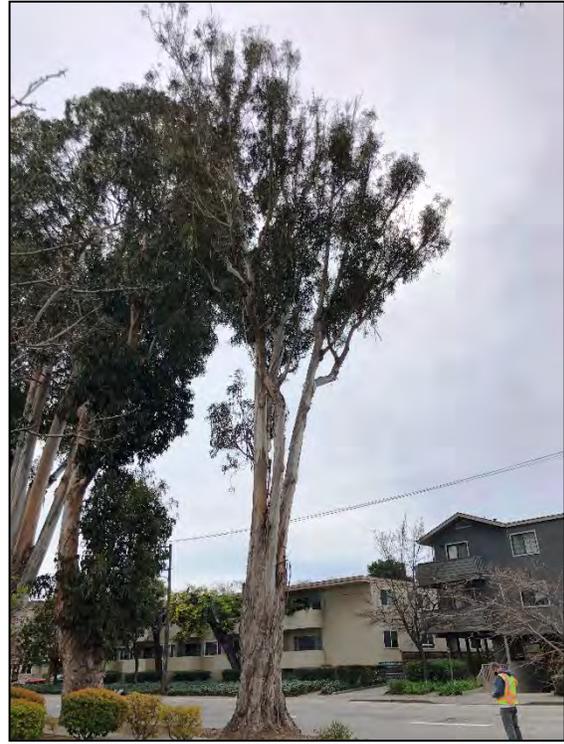
Photo 10 (R): Looking southwest at blue gum #243. It was in poor condition, with a very sparse crown and moderate dieback of twigs and branches throughout the crown.

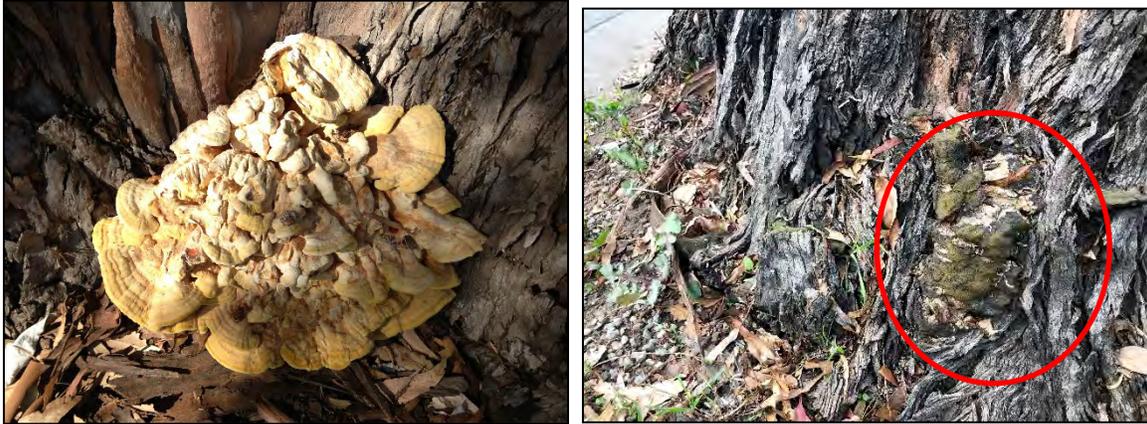
Photo 11 (L): A typical fruiting body of sulfur fungus on a blue gum eucalyptus (not one of the trees assessed on ECR). Fruiting bodies form in late summer and early fall in the Bay Area, starting as soft, fleshy and orange and degrading to dry, chalky and white.

Photo 12 (R): Looking at the base of blue gum #113, shows the degraded fruiting body of sulfur fungus (circle). All of the sulfur fungus observed as part of our field work was in a degraded state.

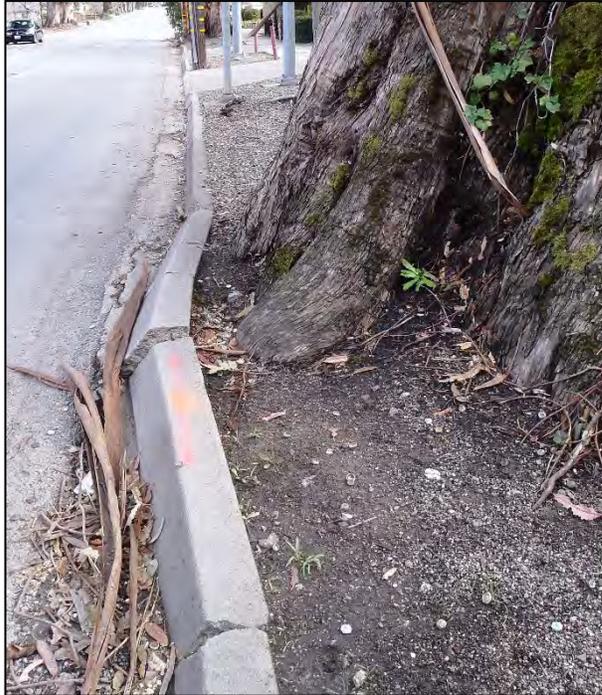
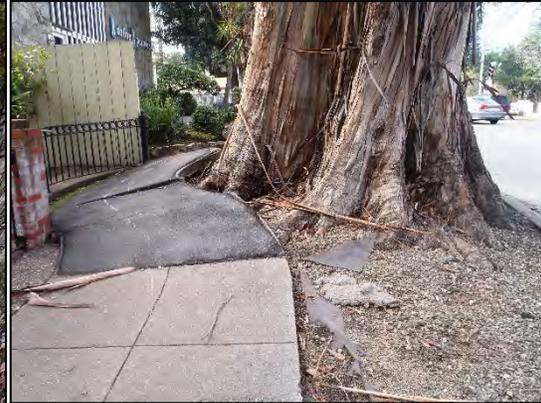
Photos 13 (R) and 14 (above): Show the level of damage to curb and sidewalk caused by the base of blue gum #477.

In this case, the base of the tree had outgrown the available growing space, causing severe damage to both the adjacent sidewalk and curb.

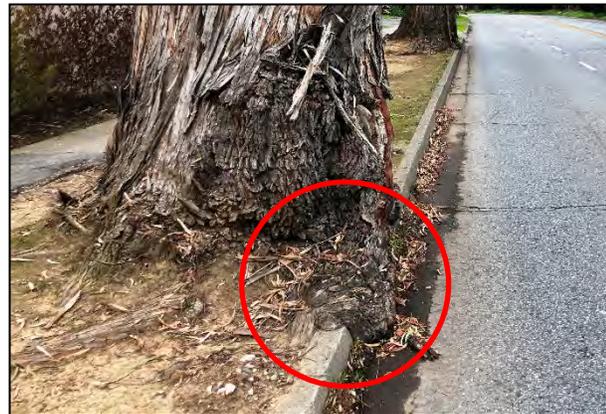
Photo 15 (R): Looking south at the base of tree #193. The trunk had pillowed over the curb (circle) and the tree had outgrown the available space.

Although displacement of the curb was minor there is no way to repair or replace the curb without cutting into the trunk of the tree.

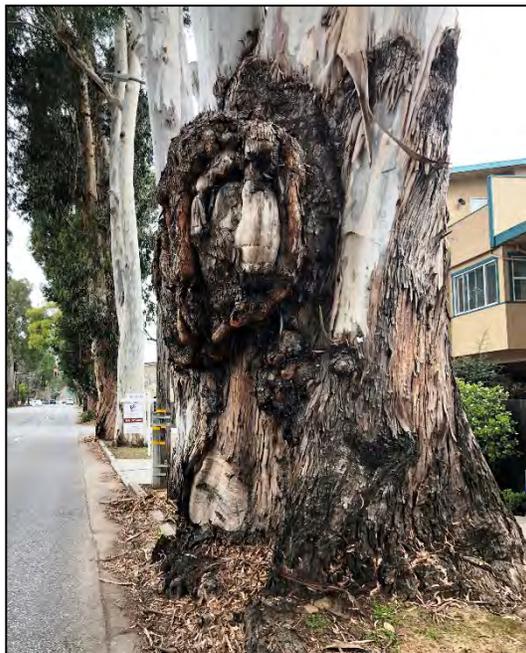
Photo 16 (L): Looking north at the trunk of blue gum #139. The trunk had been struck multiple times, causing permanent damage.

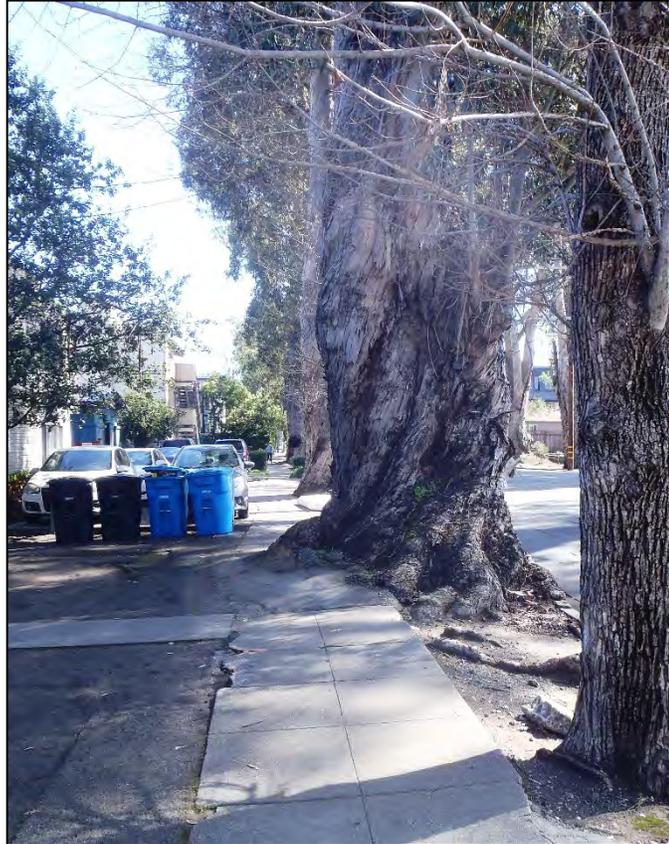
Photo 17 (R): Looking south from the driveway of 1324 ECR. This location represents one example of the proximity of trees to access points and the impact of the size of the trees.

The address is an apartment building with a driveway flanked by blue gums #68 and 69, both of which measure 65” in trunk diameter. The sheer size of the trunks creates a narrow passage for vehicles to enter/exit ECR.
