Tree Preservation Assessment

**State Route 82
El Camino Real Roadway Renewal Project
San Mateo County, CA**

**PREPARED BY:
HortScience | Bartlett Consulting
325 Ray St.
Pleasanton, CA 94566**

November 2021

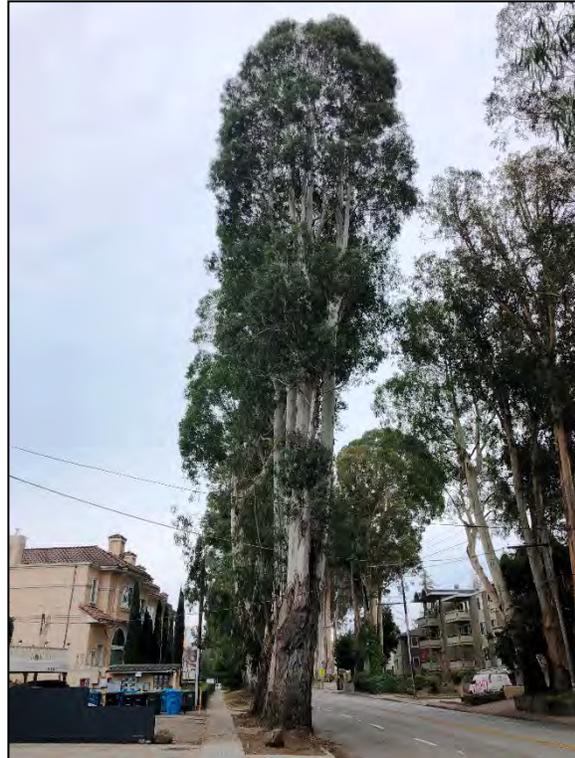
Photo 9 (L): Looking north at manna gum #437. Although the tree had been topped and reduced, it was in good condition, with better form and structure than those in fair condition.

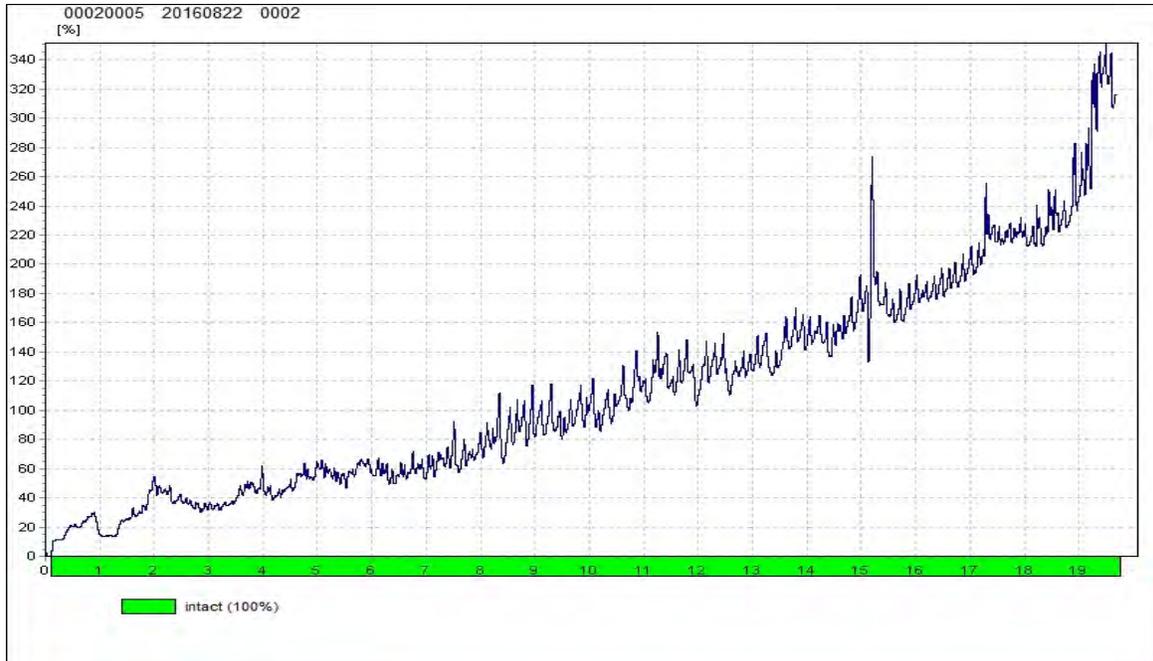
Image 1: An 'ideal' Resistograph® reading, representing a typical reading for a hardwood species with no internal decay.
